To Gather Together

After years of neglect, a restored 19th-century town hall near Boston is once again the focus of a community's pride.

Andover Town Hall Restoration Andover, Massachusetts

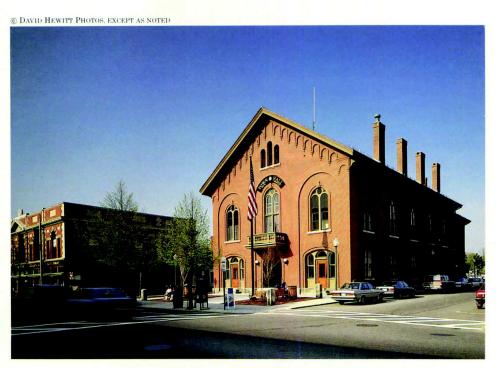
Town Hall occupies a prominent site on Main Street in downtown Andover.

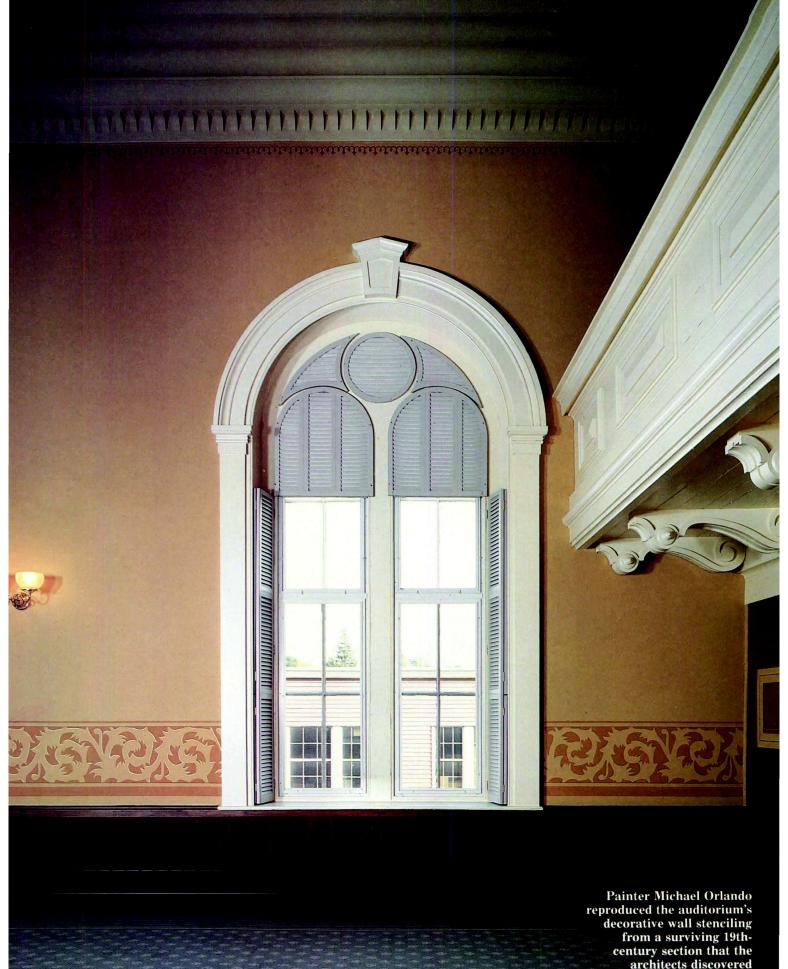
Painter Michael Orlando reproduced the auditorium's decorative wall stenciling from a surviving 19th-century section that the architects discovered underneath later wood paneling. Repainted window shutters are original.

In the auditorium 80-year-old painter Michael Orlando reproduced 19th-century wall stenciling from a surviving section that project architect Pamela Hawkes discovered

beneath later wood paneling. The auditorium's original plaster cornice and stage frame, removed during the 1950s, were refabricated in glass-fiber-reinforced concrete with the help of a 19th-century plasterer's handbook and a single discarded modillion found behind a door. The room's air-conditioning supply grilles are set neatly between stencil patterns in the ceiling, while brass chandeliers and sconces are stock items that evoke the spirit, if not the exact detail, of the original gas fixtures. The architects chose to furnish the auditorium with 200 modern contract stacking chairs because, according to Hawkes, "the building never had fancy seating before—just utilitarian wood benches—and the town required easily removable seats."

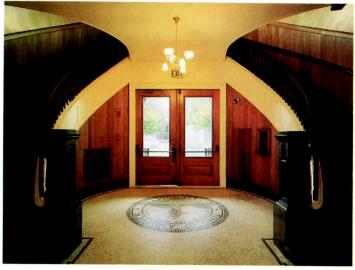
A curved stair (top right) leads to the restored auditorium (below right). Aided by a 19th-century pattern book, the architects replicated the room's plaster cornice in glass-fiber-reinforced concrete.

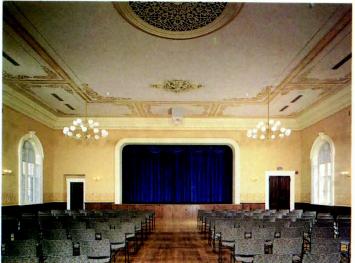
The auditorium before \$2.1-million restoration.
